Manhole Inspection Summary

Manhole # S43OO_038MH

Insp Date: **12/11/07 10:04 AM**

Location Address: **Darley Avenue**

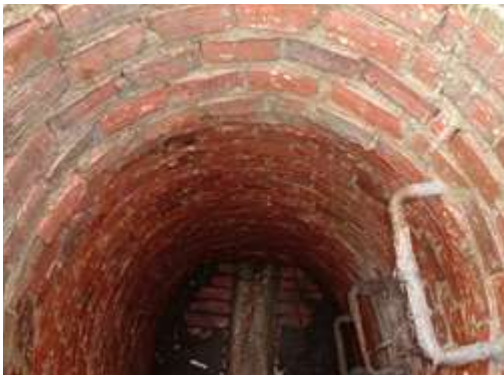
Defect 1

☒ **Leaks**

Infiltration: ☐ None ☐ Joint ☐ Cracks ☒ **Mortar** ☐ Roots ☐ Wall

Infiltration: ☐ None ☐ Joint ☐ Cracks ☐ Mortar ☐ Roots ☒ **Wall**

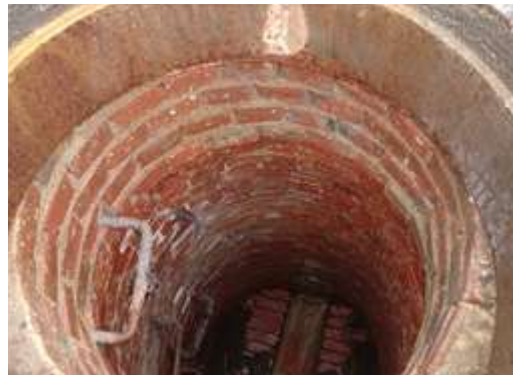
Defect 2

Count: **2** Missing: **0** ☒ **Corroded**

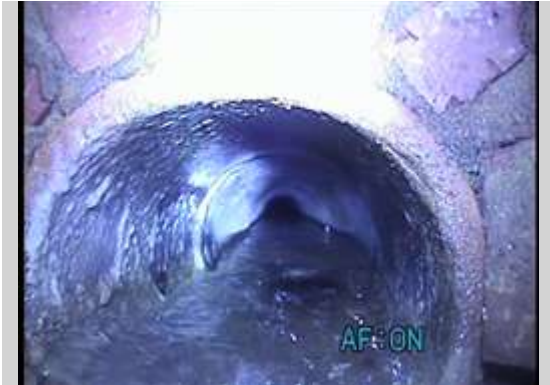
12 O'Clock Outflow

10 in. Circular Gravity Sewer
Pipe Out @ 12 O'Clock

Pipe Height: **9.6** (in.) Rod and Bar (Angled)
Pipe Material: **Clay** ☐ Pipe Lined
Invert Depth: **9.03** (ft.) Flow Characteristics: **Slow**
Deposits: ☒ None ☐ Mud ☐ Sludge ☐ Debris ☐ Grease
Silt Depth: (in.) Deposits Extent:
Infiltration: **None** Pipe Seal Cond: **Sound**

Drop: **None**

Connects To: **Manhole**

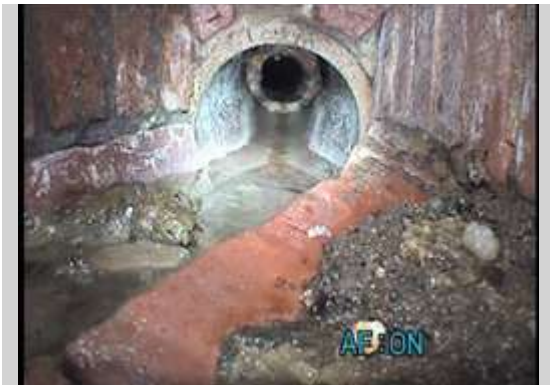
3 O'Clock Inflow

8 in. Circular Gravity Sewer
Pipe In @ 3 O'Clock

Pipe Height: **8.4** (in.) Rod and Bar (Angled)
Pipe Material: **Clay** ☐ Pipe Lined
Invert Depth: **8.79** (ft.) Flow Characteristics: **Slow**
Deposits: ☒ None ☐ Mud ☐ Sludge ☐ Debris ☐ Grease
Silt Depth: (in.) Deposits Extent:
Infiltration: **None** Pipe Seal Cond: **Sound**

Drop: **None**

Connects To: **House connection / Service line**

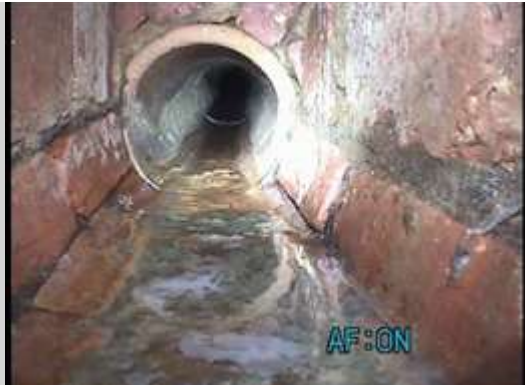
6 O'Clock Inflow

10 in. Circular Gravity Sewer

Pipe In @ 6 O'Clock

Pipe Height: **9.6** (in.) Rod and Bar (Angled)

Pipe Material: **Clay** ☐ Pipe Lined

Invert Depth: **9.00** (ft.) Flow Characteristics: **Slow**

Infiltration: **None**

Pipe Seal Cond: **Sound**

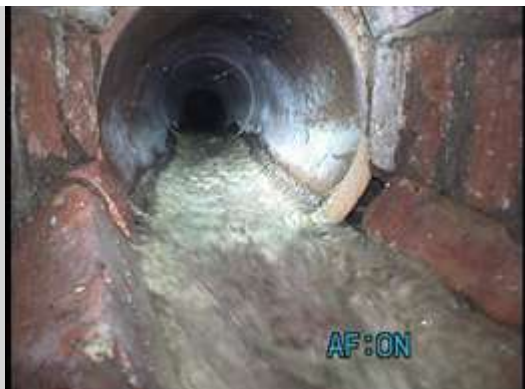
9 O'Clock Inflow

8 in. Circular Gravity Sewer

Pipe In @ 9 O'Clock

Pipe Height: **8.4** (in.) Rod and Bar (Angled)

Pipe Material: **Clay** ☐ Pipe Lined

Invert Depth: **8.70** (ft.) Flow Characteristics: **Slow**

Infiltration: **None**

Pipe Seal Cond: **Sound**
